Stanford University's Old Union Restoration of Decorative Corbels Stonesculpt, 2007

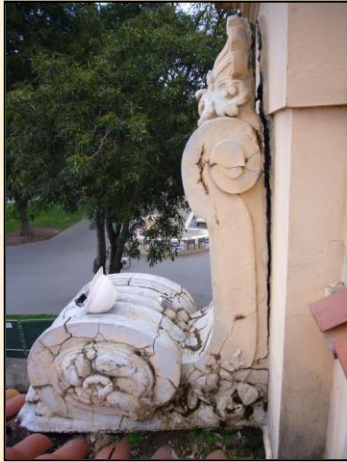
Before restoration

Originally built circa 1922, the two large corbels adorning the main entrance of Stanford's first student union have experienced severe deterioration over the past 85 years. The corbels were constructed from precast concrete, and were designed to be hollow inside with steel bars running throughout for reinforcement. As water penetrated through the corbels, the steel reinforcements began to rust and expand, causing severe cracks throughout. In many places, large chunks of the corbels had fallen off, or were sitting loose in place. Additionally, the tops of the corbels were separated from the wall and slowly falling forward.

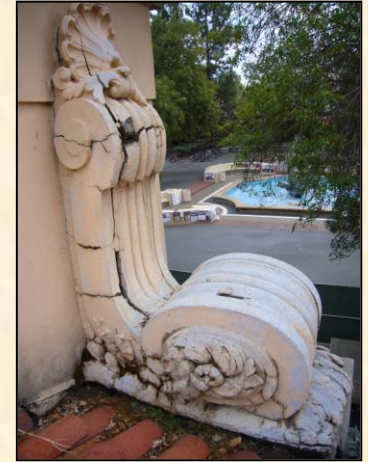
Before restoration
